Hollister Incorporated
2000 Hollister Drive
Libertyville, IL 60048

URGENT PRODUCT FIELD SAFETY NOTICE

Onli™ Hydrophilic Urethral Intermittent Catheter

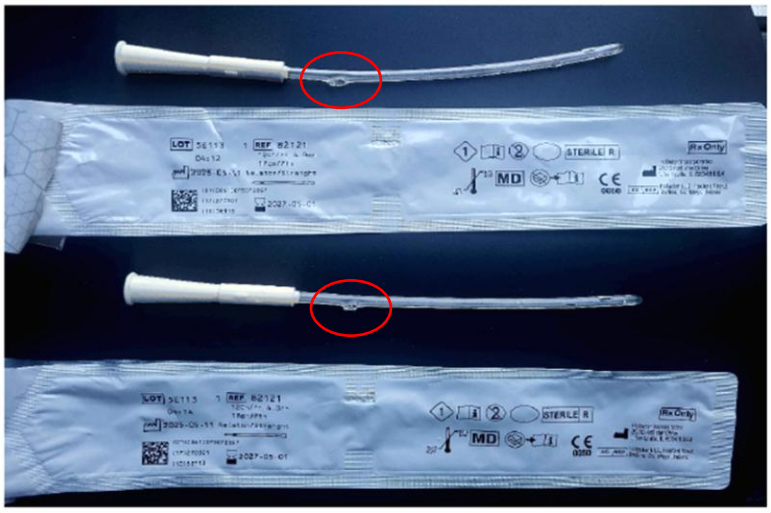
Image 1

The reason for this Product Field Safety Notice is Hollister has identified that select lots of the catheters identified in the above table may exhibit a protrusion caused by a manufacturing defect which might lead to genitourinary trauma or bleeding. This defect is approximately 2 centimeters from the funnel (refer to image #1 and #2 below). Defect highlighted in red circle.

Step #2: If you are in possession of an affected lot, you may continue to use the device but **should inspect each catheter at the time of use for the potential presence of a protrusion located approximately 2 cm from the funnel** (as described in Images 1 and 2). **If a protrusion is identified, the catheter should not be used.** Users should also review and follow the Instructions for Use (IFU) and ensure that the device is opened, handled, and inserted in accordance with the IFU.
